DEPARTMENT OF TRANSPORTATION

Contract #: 04-0120F4Cty: SF/ALA Rte: 80 PM: 13.2/13.9File #: 69.28**WELDING INSPECTION REPORT****Resident Engineer:**Pursell, Gary**Address:** 333 Burma Road**City:** Oakland, CA 94607**Report No:** WIR-015494**Date Inspected:** 07-Jul-2010**Project Name:** SAS Superstructure**OSM Arrival Time:** 700**Prime Contractor:** American Bridge/Fluor Enterprises, a JV**OSM Departure Time:** 1900**Contractor:** Zhenhua Port Machinery Company, Ltd (ZPMC), Changxing Island **Location:** Shanghai, China

Bridge No: 34-0006**Component:** OBG Trial Assembly**Summary of Items Observed:**

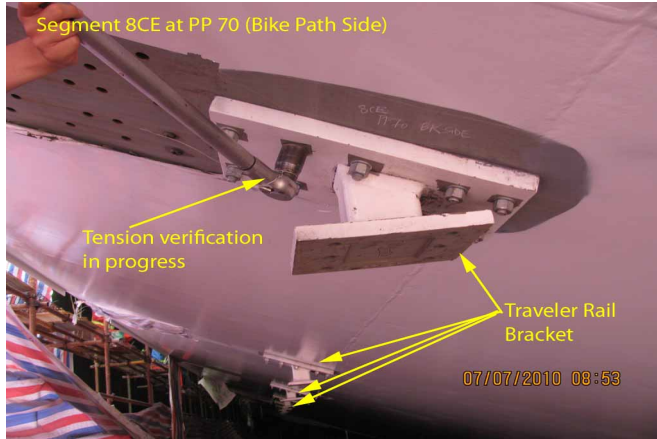
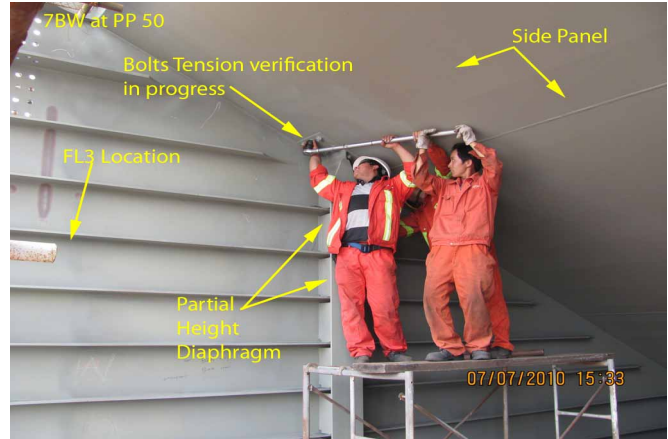
This QA Inspector witnessed the final bolt tension verification on bolts connecting the Traveler Rail Bracket to the Side Panel at Panel Points (PP) 68, PP 69, PP 70 and PP 71 for Segment 8CE. The QA Inspector verified the bolt tension on a random basis and the results appeared to be in general compliance. The Inspection was performed against Notification No. 00411 dated July 07, 2010.

The manual torque wrench used to verify tension was S/N XQ2-666. Please reference the pictures attached for more comprehensive details.
